SUMP DEPRESSURIZATION AND VENTING REPORT
FORMER MANUFACTURING PLANT BUILDING
2, 4 FOSTER AVENUE AND 3 UNITED STATES AVENUE
GIBBSBORO, NEW JERSEY

July 2016

**PHOTO LOG
SUMP VENTING INSTALLATION ACTIVITIES
JUNE 9TH THROUGH JUNE 13TH**

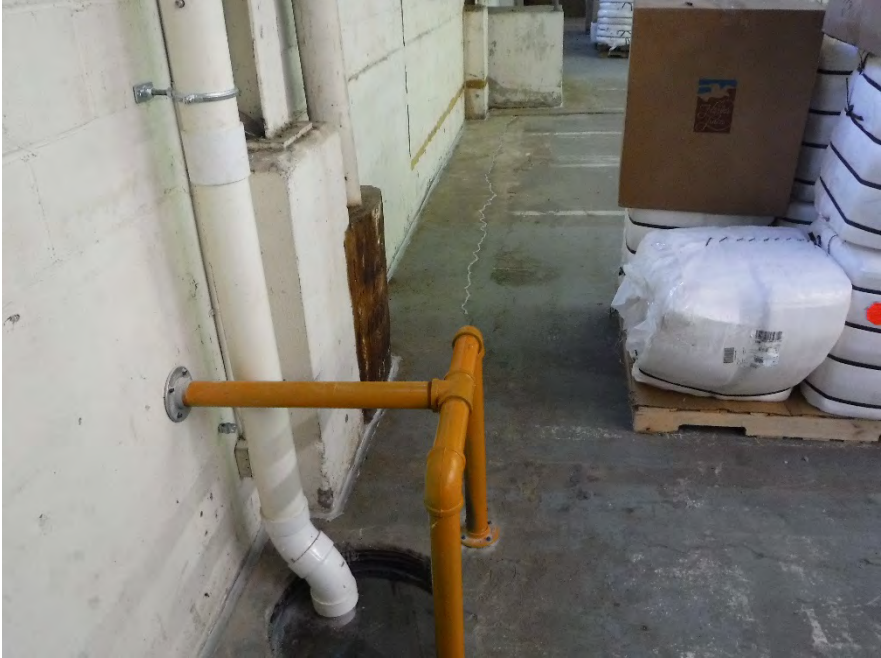
Photo No. 1	Sump 1 sealed and vent stack

Clean Vapors completed installation of Sump 1 sealing and venting system. The temporary sump located at Sump 3 was removed and replaced by a commercially available plastic sump liner similar to Sumps 1 and 2. Holes were drilled into the bottom of Sump 3 to allow water collected in the sump to drain to the subsurface. The area surrounding the sump was leveled and sealed with concrete.

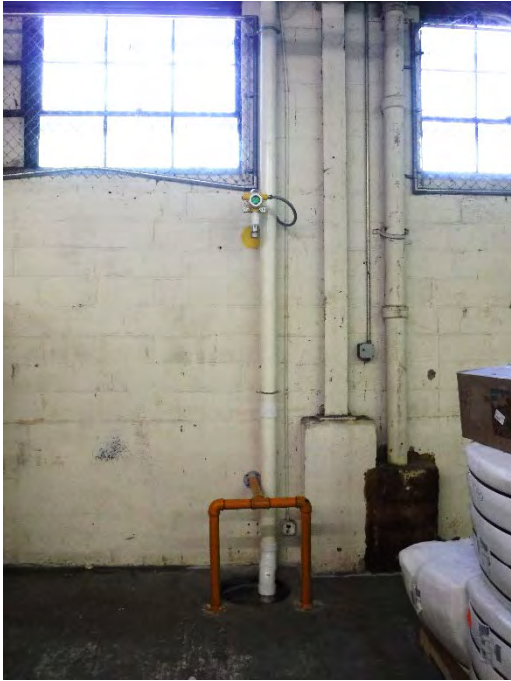
Photo No. 2	Sump 1 vent stack and new LEL sensor location.

- Sensepoint XCD Lower Explosive Limit (LEL) sensors originally installed in Sumps 1, 2, and 3 were proposed for relocation to ceiling height in the Work Plan. However, due to health and safety issues associated with working at elevated heights and the associated complications with maintaining and calibrating the LEL sensors, the former in-sump sensors were relocated to 8 feet above the building slab immediately above the corresponding sumps.

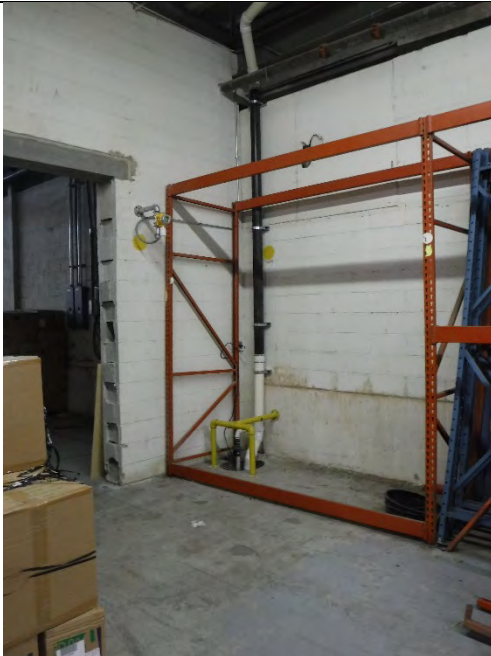
Photo No. 3	Sump 2 sealed, vent stack and new LEL sensor location.

Clean Vapors completed installation of Sump 2 sealing and venting system. Approximately 101 feet of cracking and slab gaps associated with a French drain located along the exterior wall near Sump 1 were sealed using a polyurethane caulking (Vulkem 911). A 2-inch portion of the crack located under 3 United States Avenue could not be sealed during this mobilization as discussed in Section 2.1. Electrical subcontractor, Mechanical Solutions Associates (MSA), relocated Sensepoint XCD LEL sensors 1, 2, and 3 to 8-feet immediately above each sump. Weston completed calibration of the sensors in accordance with the manufactures recommendations using 50% methane and 20.9% oxygen balance nitrogen (Northside Sales, Co. Lot CAQ-135S-2.5-7, expiration date February 25, 2020).

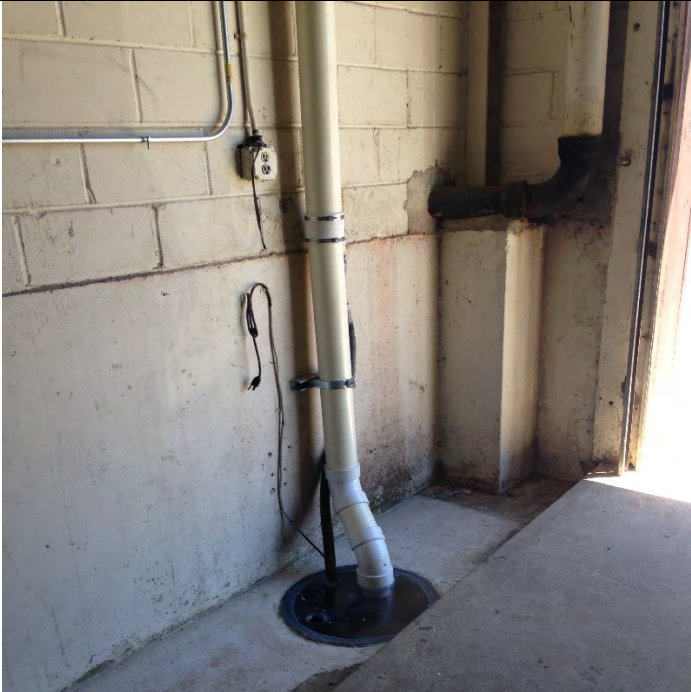
Photo No. 5	Sump 3 sump sealed and vent stack.

Clean Vapors completed installation of Sump 3 sealing and passive venting system. Additional cracks observed around Sump 1 and 2 were sealed. Jottan Roofing, retained by Clean Vapors at the request of Brandywine, completed the three roof penetrations associated with the passive sump vents. Metal flashing was installed around the vent stacks and liquid roofing adhesive was placed in and around each flashing.

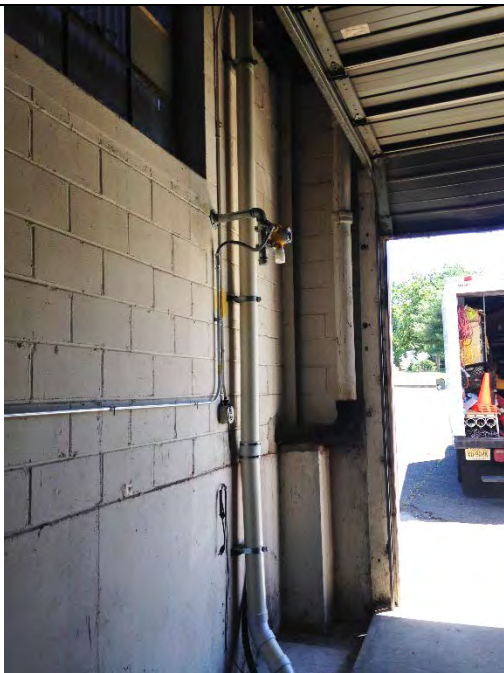
Photo No. 6	Sump 3 vent stack and new LEL sensor location.

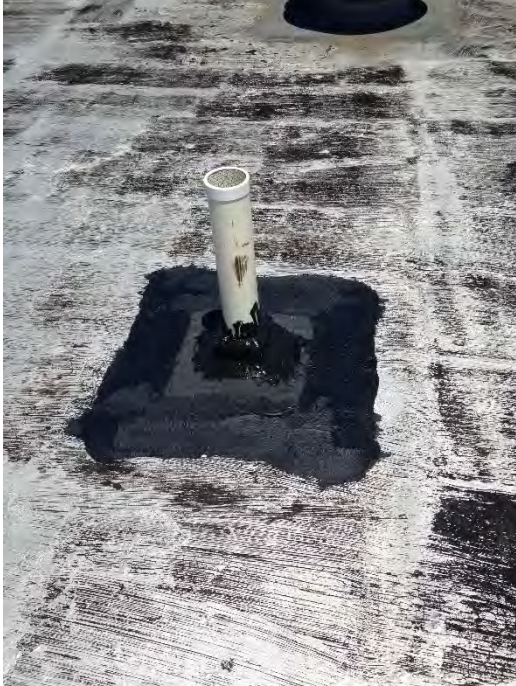
Photo No. 7	Typical roof vent stack penetration repair.

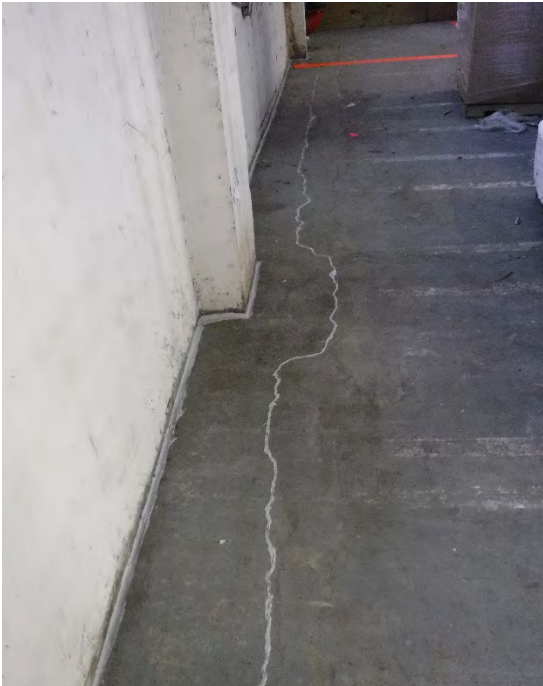
Photo No. 8	Sump 1 floor crack repairs (2 Foster Ave.)

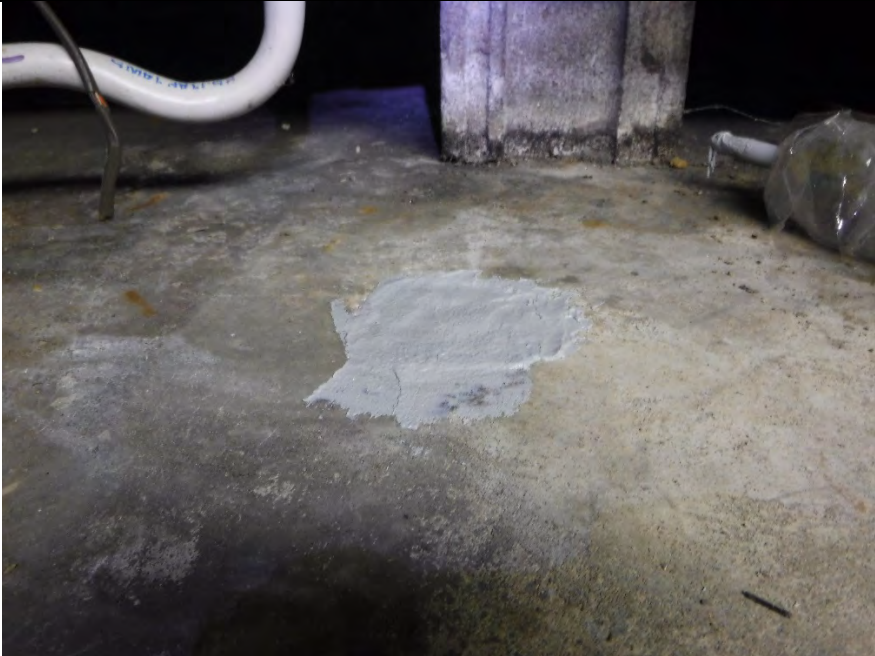
Photo No. 10	Hole in slab near HVAC unit in 3 United States Ave crawlspace.

- A cracks and slab expansion joint gaps associated with a French drain located along the exterior wall near Sump 1 were to be sealed during the sump venting event. The cracks and expansion gaps extend from Sump 1 located in 2 Foster Avenue to the 3 United States Avenue crawls space. A heating, ventilation, and air-conditioning (HVAC) unit condensate line drains into a portion of the crack located under 3 United States Avenue and will need to be relocated at a later date. A small portion of the crack could not be sealed due to the presence of the drain line and will be sealed once the drain line is relocated by Brandywine.
